Fickes Holistic Care Corp

Dr. Linda Fickes, D.C., Board Certified Medical Thermographer, Board Certified Clinical Nutritionist
824 Hahaione St.,
Honolulu, Hawaii 96821 USA
Phone: 808 395-6800 Fax: 808 396-0919
Celiac Presentation with Thermal Imaging

Type Of Exam: Full Body
Female, age 55

Date of Exam: November 05, 2010
Reported By: Dr. Linda Fickes, D.C.

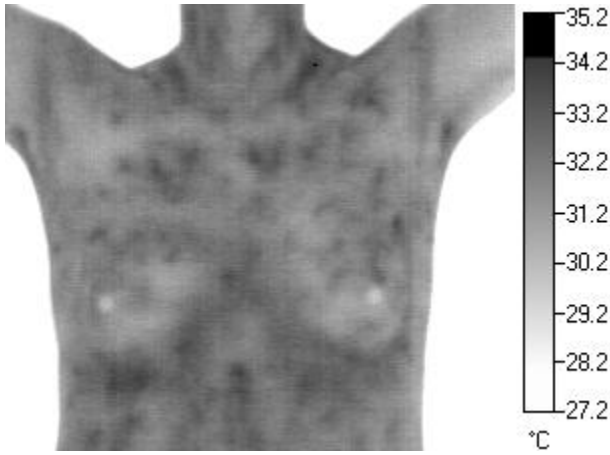
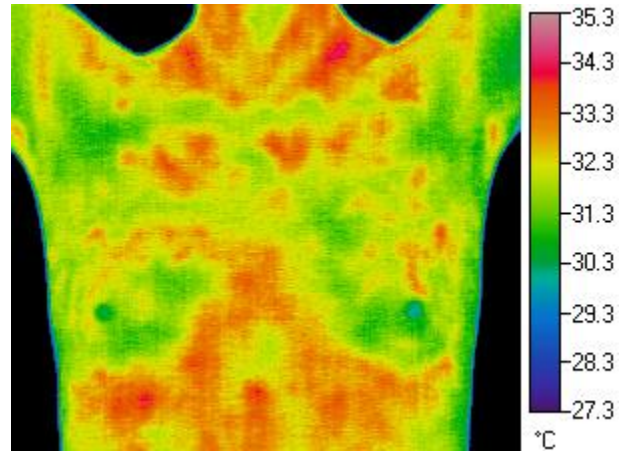
Ant. Breast

Thermographic Findings: Hot blotchy lymphatic inflammation throughout the trunk is apparent, indicating immune system irritation, common with gluten sensitivity. These heat patterns emanates from the severe inflammation in the small intestine, colon, liver and gallbladder, seen below, typically damaged by gluten.

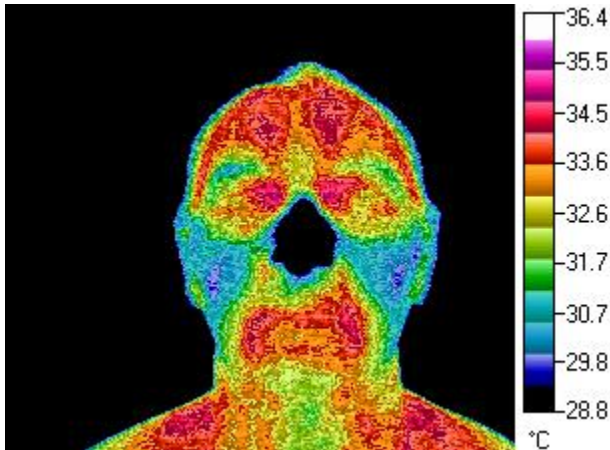
Ant. Cranial Facial

The forehead heat pattern indicates diminished blood flow to the brain, another common sequela of gluten sensitivity. Thyroid is colder and more inactive than optimal. Thyroid is a common place for auto-immune attack with gluten sensitivity.
